National Register of Historic Places Registration Form

Historic name: Brooklyn Presbyterian Church

Street & number: 1433 12th Avenue

City or town: Oakland State: California County: Alameda

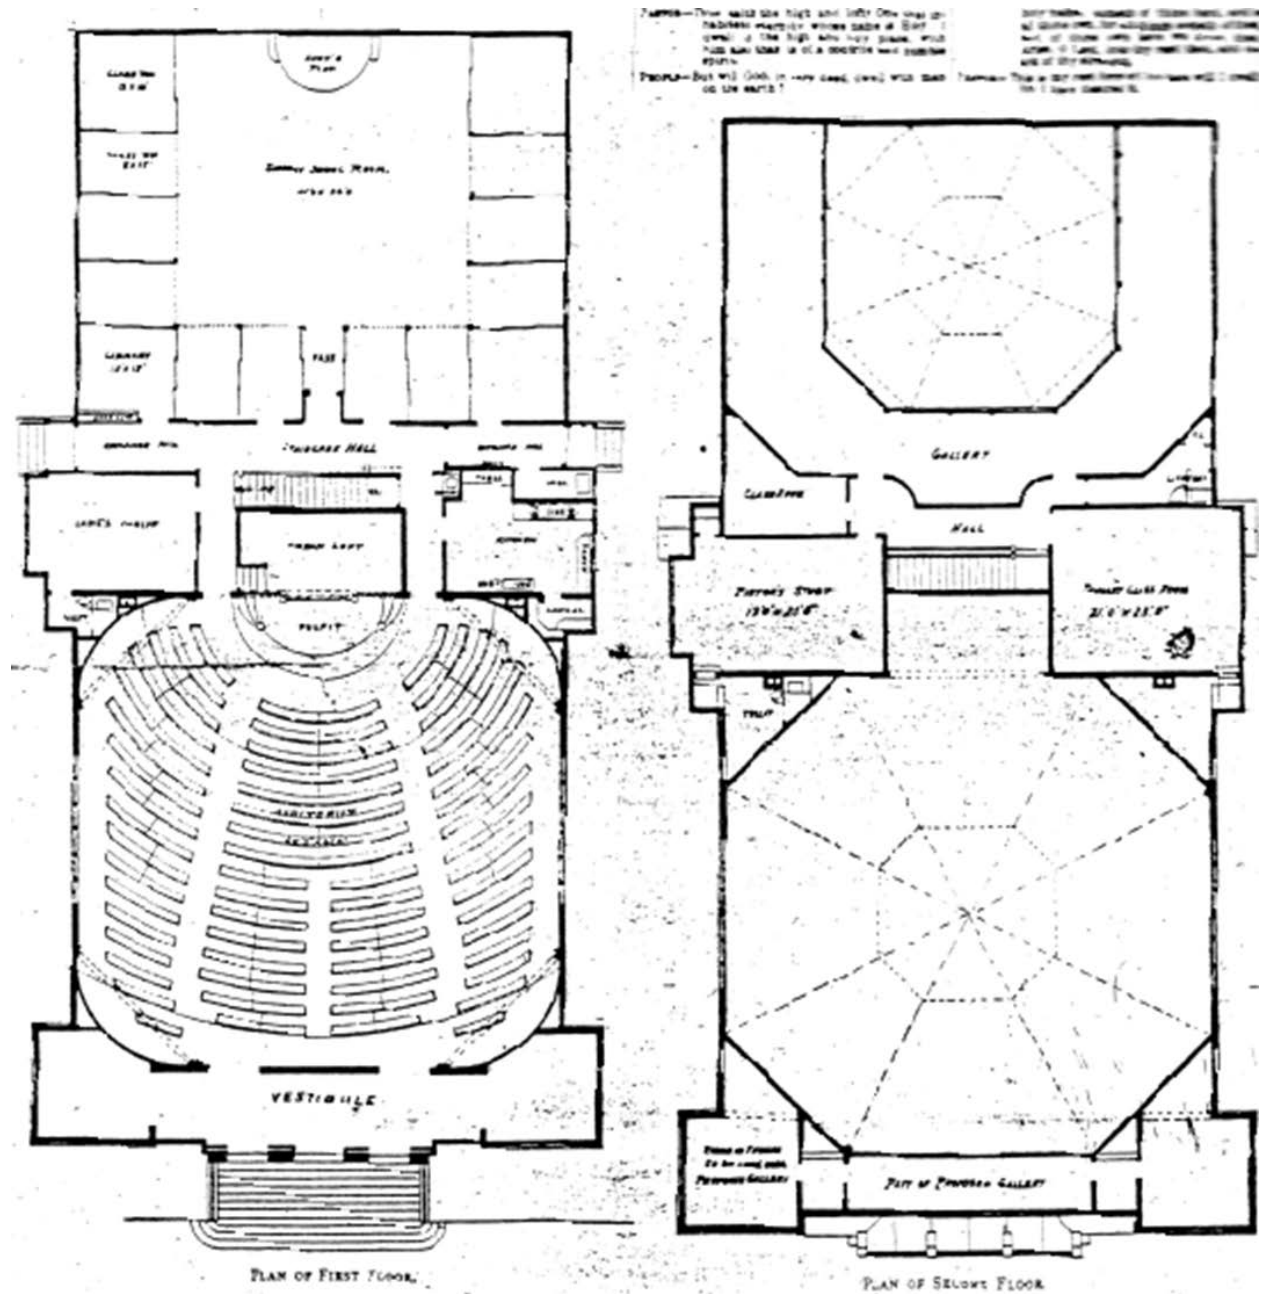
Figure 6. Original floor plan obtained from *The Christian Home* archive, August, 1887

The Sunday school room is 48' x 60' with a gallery located above that is twelve feet deep on three sides. Slat partitions made of white ash, eight feet in length, were drawn down from the ceiling underneath the gallery—slightly overlapping, wrapped in canvas and fastened together with brass ribbons—and in addition to triple sliding doors that drew back to the outer walls, they provided the Sunday School the option to divide into fourteen separate classrooms. These partitions are no longer in use because a ceiling was installed in 1963 to separate the Sunday school from the dome in the gallery, sectioning off the gallery into its own room entirely.⁶ The dome of the gallery is of similar construction and octagonal shape to the one in the auditorium, is also topped with a cupola, whose original stained glass has been replaced with clear glass, and is to a smaller scale. A kitchen, rare for churches of the time, was outfitted before even the pews were installed. It connected to the main Sunday school room via a pass window, since closed off.

The cornerstone of Brooklyn Presbyterian Church was laid July 16, 1887. A block of marble presented by Oakland's Amador Marble Company marked the completion of the church's construction. The official coronation occurred later that year on Christmas Day, where "a vast concourse of people" assembled to witness the ceremonies, which included the presentation of speeches and hymns sung amidst a copious display of flowers and evergreens, swinging in "graceful pendant boughs from the rough scantling."²⁰ Reverend W. H. Hamilton spoke of the early struggles of the church when a little band fought against "the fearful odds of pioneer life" and described the 1861 establishment as the First Presbyterian Church of Brooklyn. Addresses were made by the pastor, Dr. E.S. Chapman, and visiting ministers from around the San Francisco Bay Area. The organ, which came from the recently dissipated Starr King Church in San Francisco, furnished music for the occasion. A complete account of the day's festivities, the names of residents who supported the church and its broad-ranging activities, and a list of the cornerstone's contents appears in the featured article cited in *The Christian Home*.
